# Service Calibrations

## Service Calibrations

## Automatic PRS Adjustment

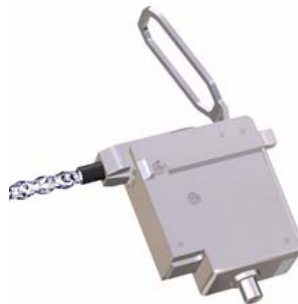
The PRS Adjustment Tool consists of two separate tools:

- PRS Pen.
- Line Calibration Stand.

PRS Pen

Line Calibration Stand

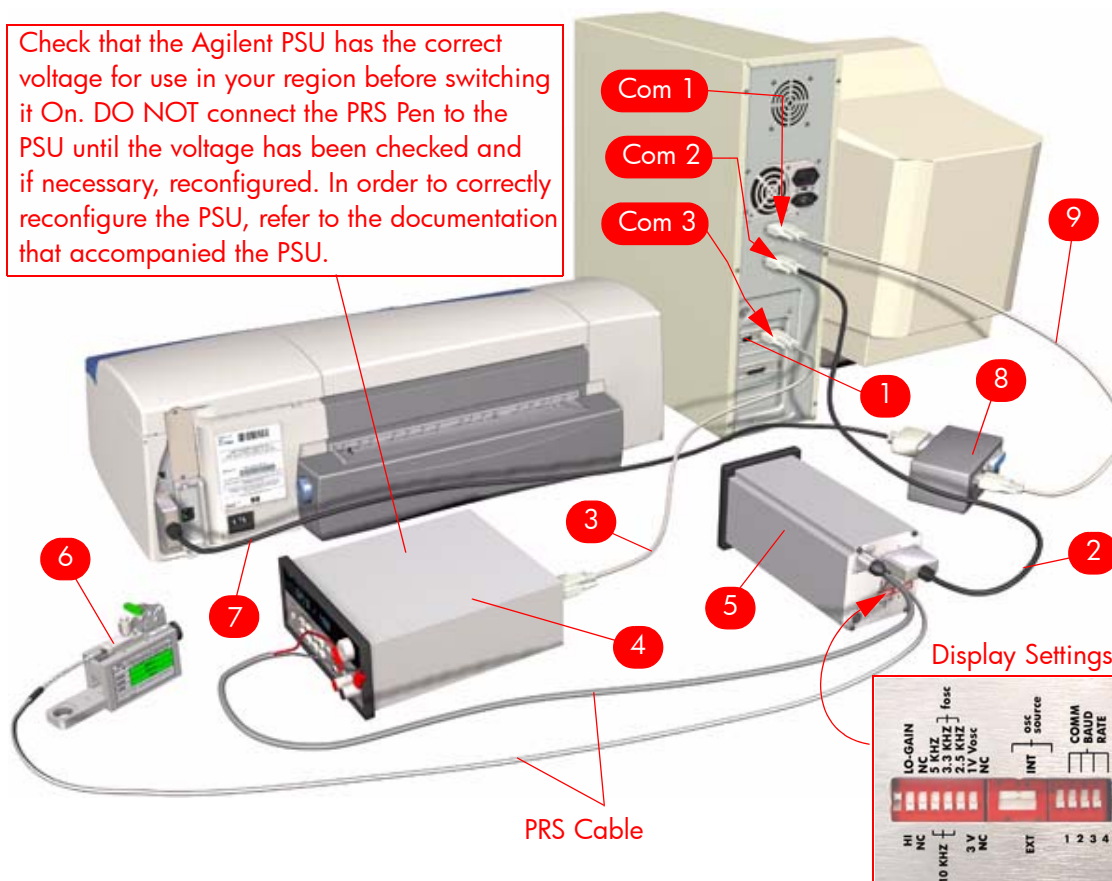
The equipment for the PRS Adjustment Tool needs to be set-up as follows:

- 1** PCS Card 2 Serial Ports.
- 2** PC-Display Communication Cable.
- 3** Serial Cable (9 pin female-female connection).
- 4** Agilent Power Supply Unit (Part Number E3640A).
- 5** Lucas-Shaevitz MP1000 Display.
- 6** PRS Pen.
- 7** Centronics (parallel) Cable (female-male connection).
- 8** Parallel-Serial Adapter.
- 9** Serial Cable (standard 9 pin female-male connection).

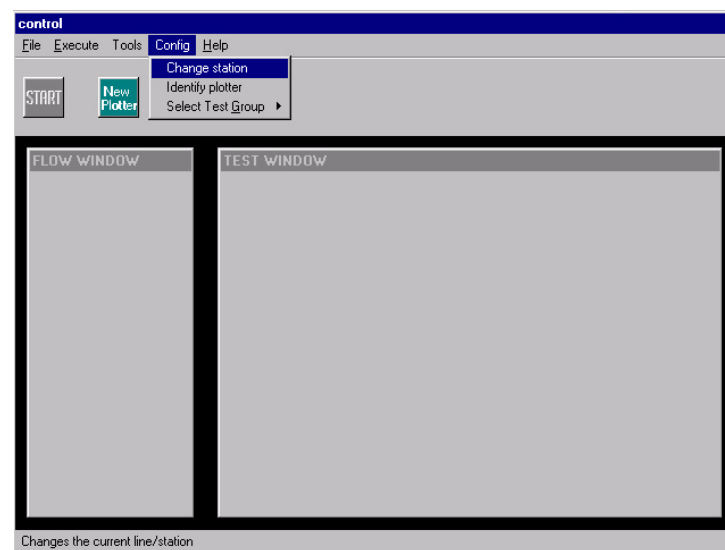
- 1 Double-click on the controller icon to start the Control Application (Version 1).
- 2 Click on **Config** and select **Change station** or click directly on the **New Plotter** box.

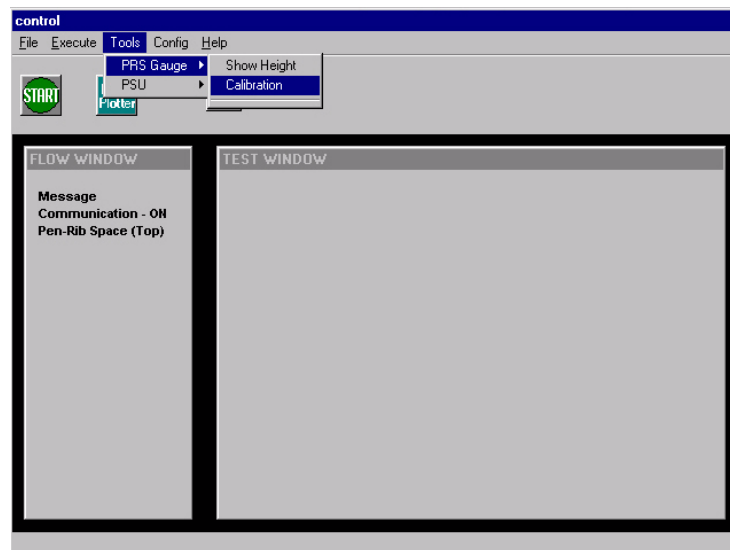
- 7 Click on **Tools**, then click on **PRS Gauge** and then click on **Calibration**.

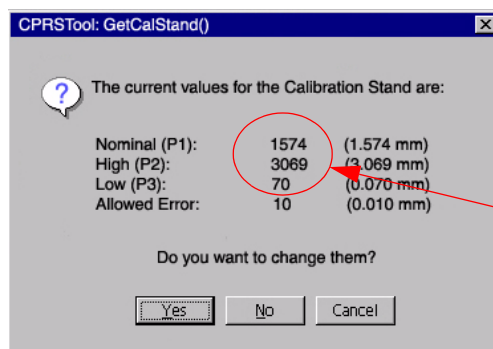
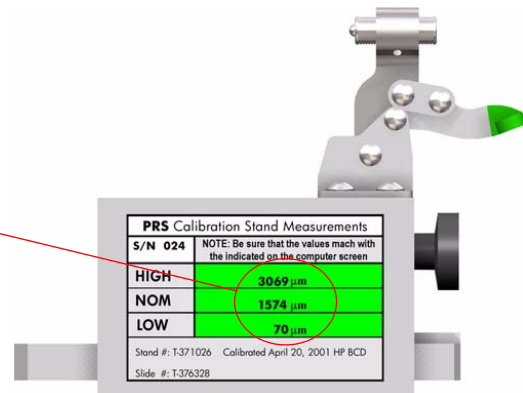
- 8 A message appears on the computer screen with the default values that are used for the calibration. Check these values against the values on the green label on the calibration Stand.

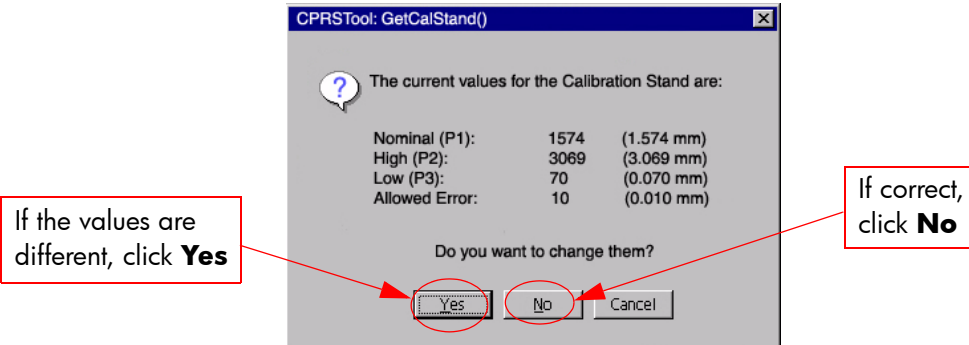
- 12** Once all the values have been entered, a message will appear on the computer screen with the values that you have just entered. Check these values against the values on the green label on the Calibration Stand to make sure they are correct and then select **No** (or select **Yes** and re-enter the values).

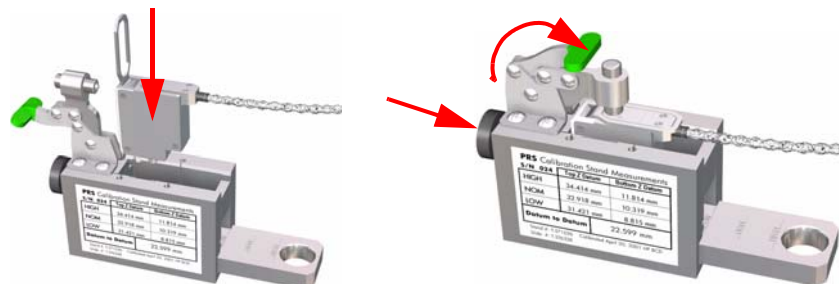
- 14** Install the PRS Pen inside the Line Calibration Stand. Release the plunger and lower the clamp into position

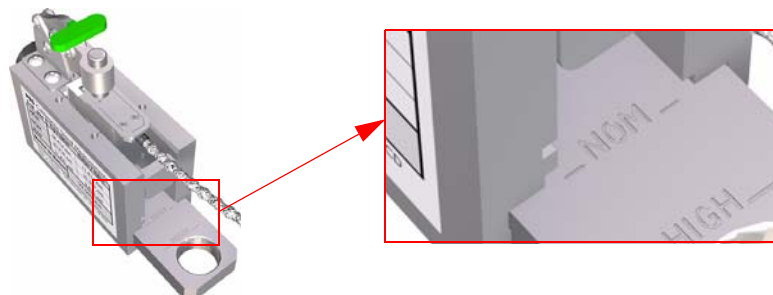
- 15** Place the Line Calibration Stand in the NOM position and click on **OK**.

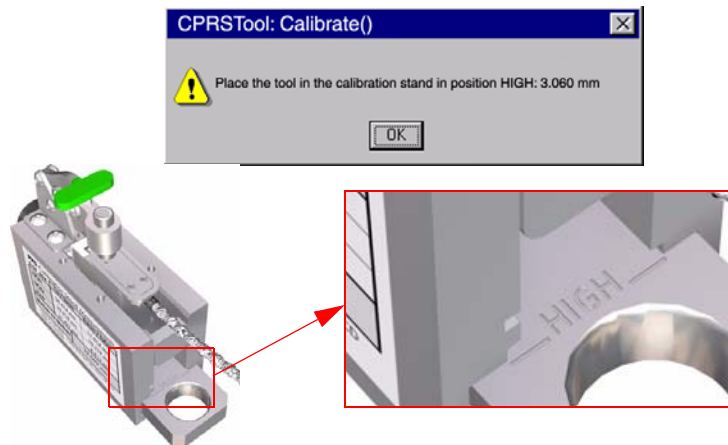
- 16** A message will appear on the computer screen requesting you to place the Line Calibration Stand in the HIGH position. Place the Line Calibration Stand in the HIGH position and click on **OK**.

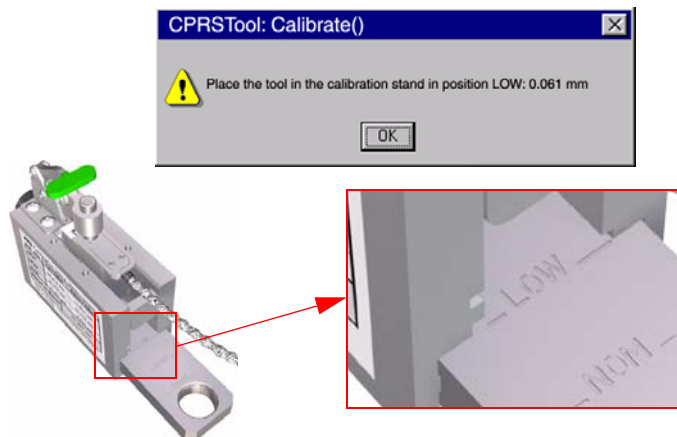
- 17** A message will appear on the computer screen requesting you to place the Line Calibration Stand in the LOW position. Place the Line Calibration Stand in the LOW position and click on **OK**.

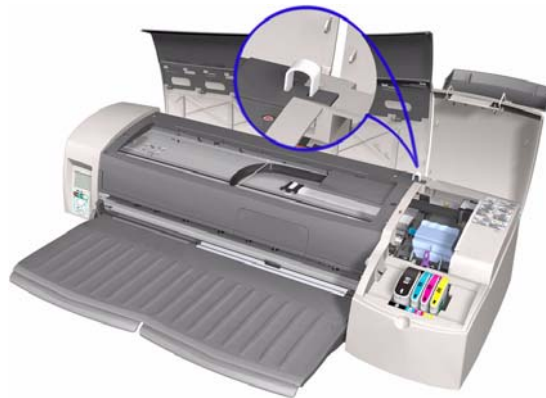
- 1 Open the Top Cover and the Printhead Access Door and block the Door Sensor with a piece of paper.

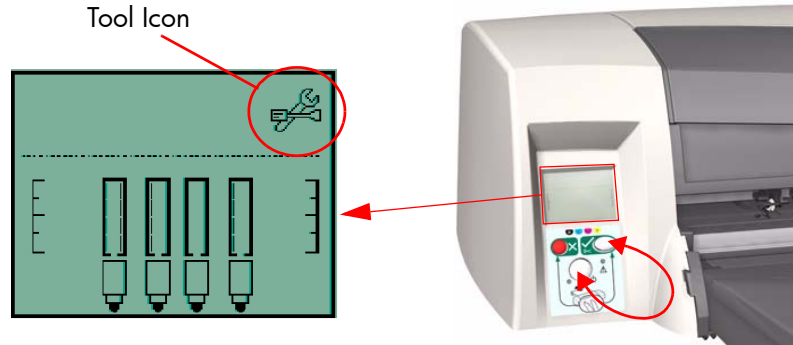
- 5 A message appears that asks you to put the printer in **MFG mode**. To do this, while the printer is switched OFF, press both the **resume** and **power** buttons together until the Tool icon appears on the front panel.

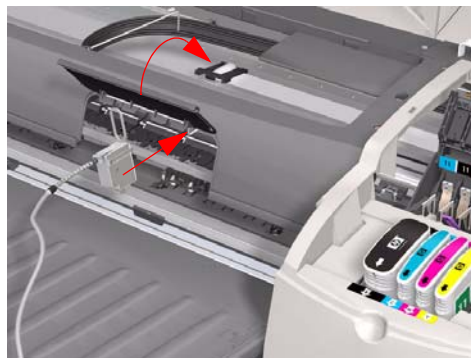
- 8 Open the Access Panel in the Center Cover and pass the PRS Tool through it.

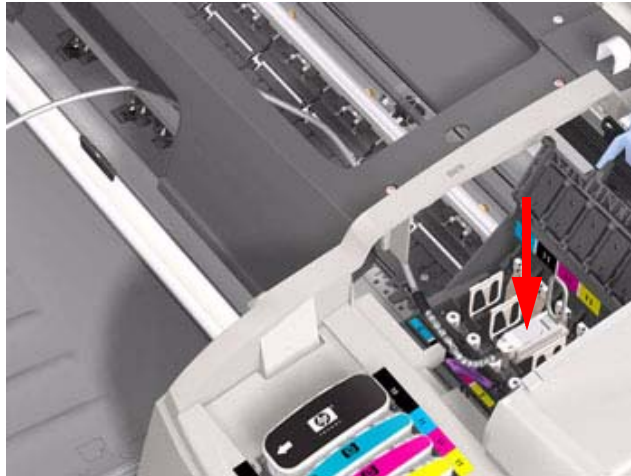
- 9 Open the Carriage Cover and install the PRS Pen into the Magenta Stall. Make sure that there is enough PRS Pen cable to allow the Carriage to move along the Scan-Axis of the Printer.

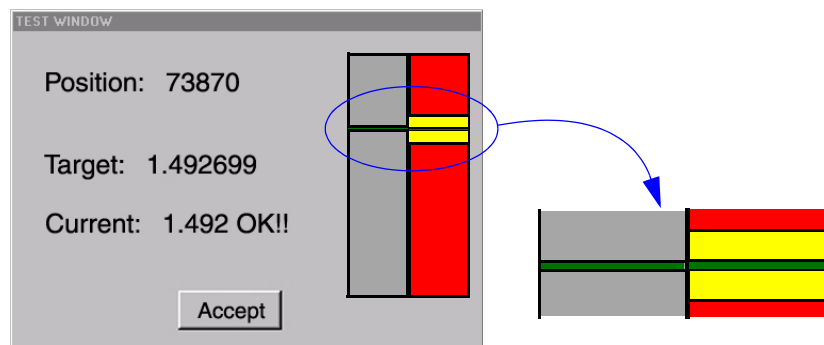
- 11 The PRS Pen measures the Pen to Rib Space along the Print Platen. Once it has taken all the measurements, the PRS Pen stops on the left hand side of the Print Platen and the PRS measurement is displayed on the computer screen.
- 12 Check the two blocks (one gray and one red) on the computer screen. If the green bar on the left block is aligned with the green bar on the right block then the measurement is within specification. Click **Accept** and the PRS Pen moves to the right hand side of the Print Platen. Again, check the two blocks on the computer screen. If the two green bars are aligned then the measurement is within specification. Click **Accept** to continue.

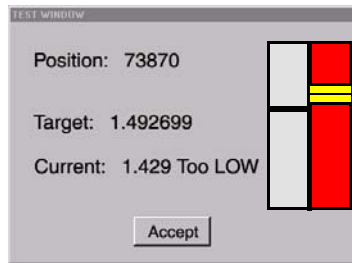
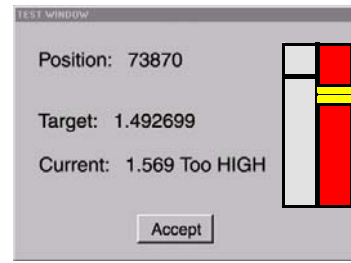
- 13** If the green bar on the left block is below or above the green bar on the right block, then the measurement is out of specification and the Pen to Rib Space needs to be adjusted.

- a** Using a very long torx screwdriver (T-8) either tighten or loosen the Pivot Assembly screw. Tightening or loosening the screw will adjust the Pen to Rib Space until the green bar on the left block is aligned with the green bar on the right block. If the current position is LOW, then tighten the screw slightly, if the current position is HIGH, then loosen the screw slightly.

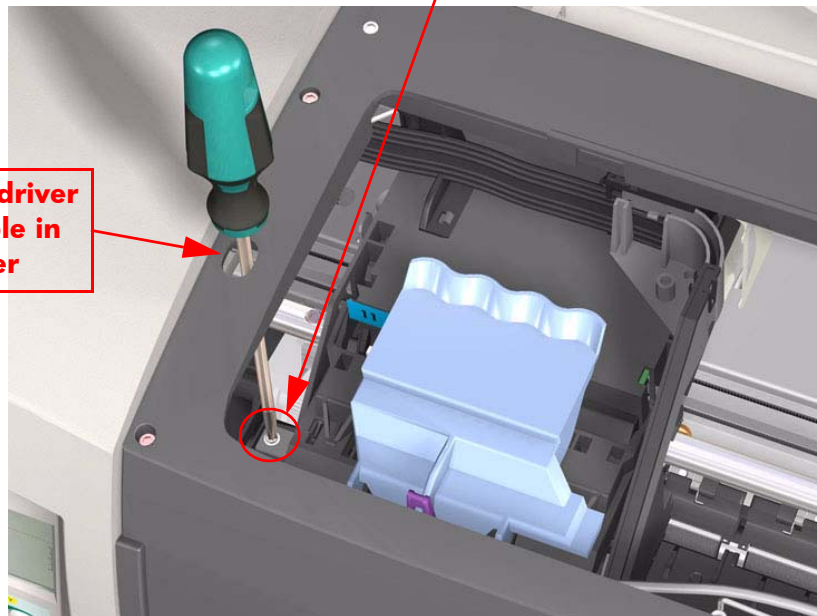
**LOW = Tighten Screw**  
**HIGH = Loosen Screw**

Tighten or Loosen the screw using a Torx screwdriver until the two green bars are aligned

**Pass the Screwdriver through this hole in the Center Cover**

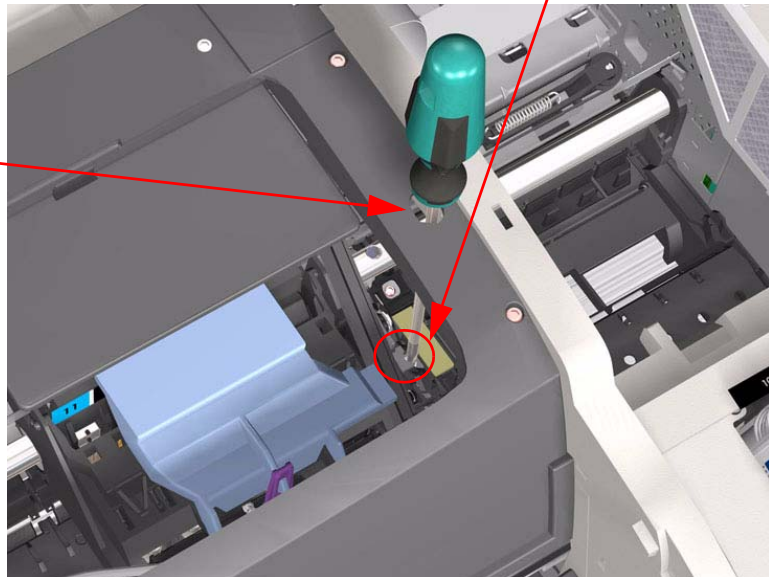
- c Using a very long torx screwdriver (T-8) either tighten or loosen the Pivot Assembly screw. Tightening or loosening the screw will adjust the Pen to Rib Space until the green bar on the left block is aligned with the green bar on the right block. If the current position is LOW, then tighten the screw slightly, if the current position is HIGH, then loosen the screw slightly.

**LOW = Tighten Screw**  
**HIGH = Loosen Screw**

Tighten or Loosen the screw using a Torx screwdriver until the two green bars are aligned

Pass the Screwdriver through this hole in the Center Cover

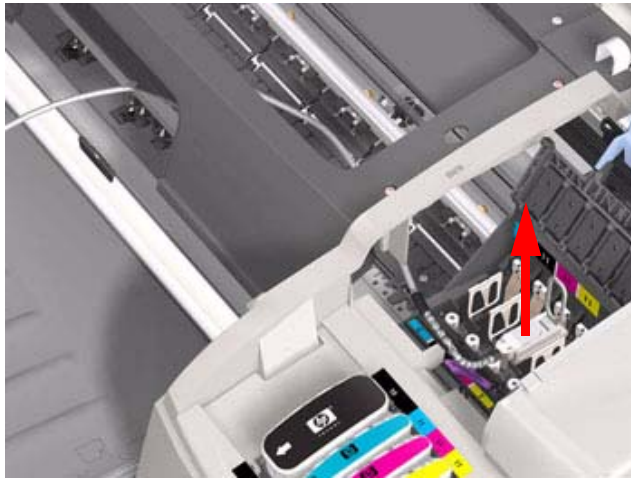
- 16 Open the Carriage Cover and remove the PRS Pen from the Magenta Stall.

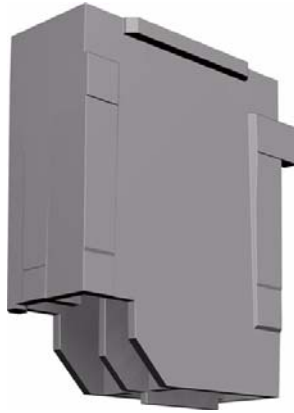
**Carriage Height Tool**

**The Manual PRS Adjustment should be carried out using the Carriage Height Tool.**

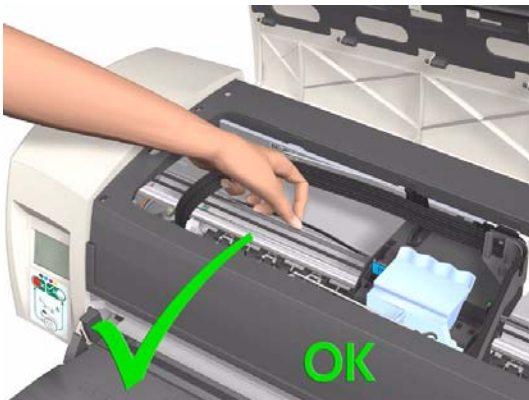
**During the Manual PRS Adjustment procedure the Carriage Assembly has to be moved along the length of the printer. Make sure that the Carriage Assembly is only ever moved by pulling the belt and never by direct contact with the Carriage itself.**

**Correct:** move using the belt.

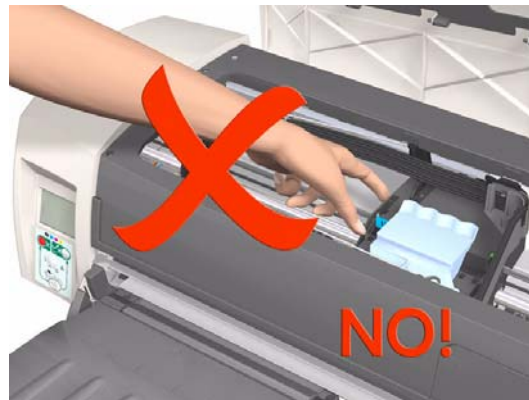
**Incorrect:** never move using Carriage Assembly.

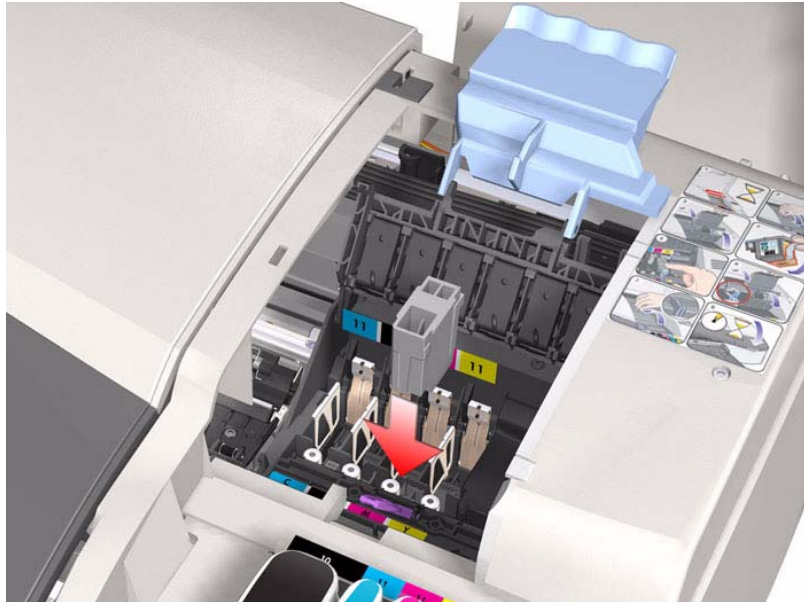
- 2 Open the Carriage Cover and install the Carriage Height Tool into the Magenta Stall - Make sure ALL the other printheads are already removed from the Carriage Assembly.

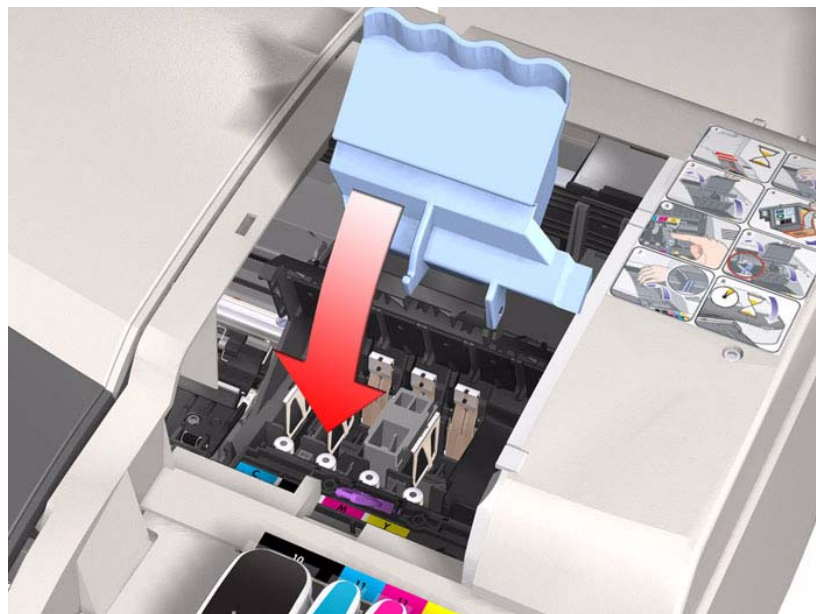
- 3 Close the Carriage Cover and switch OFF the Printer.

**Make sure that you turn OFF the Printer, otherwise you will NOT be able to manually move the Carriage Assembly.**

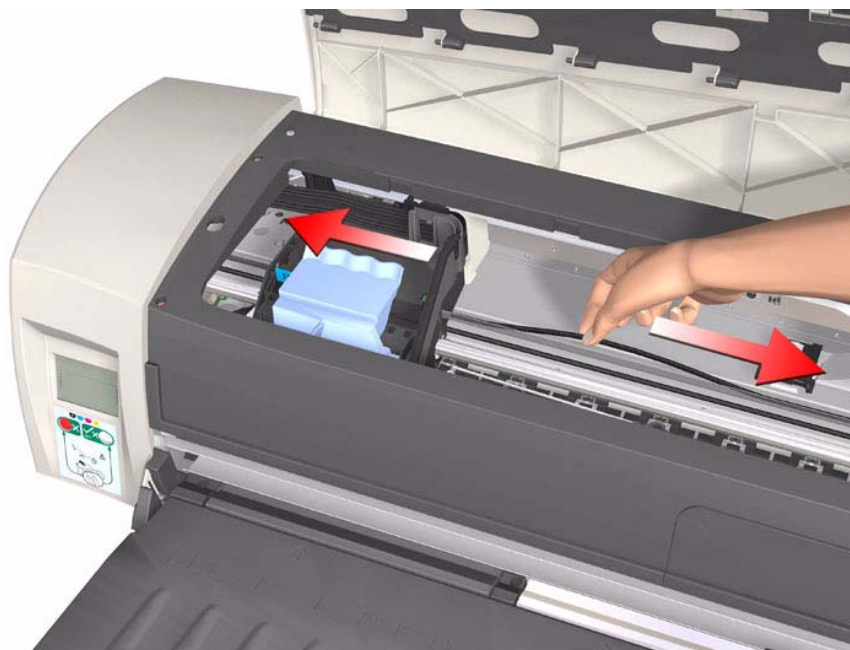
- 4** Move the Carriage Assembly to the left hand side of the Printer (to the position shown).

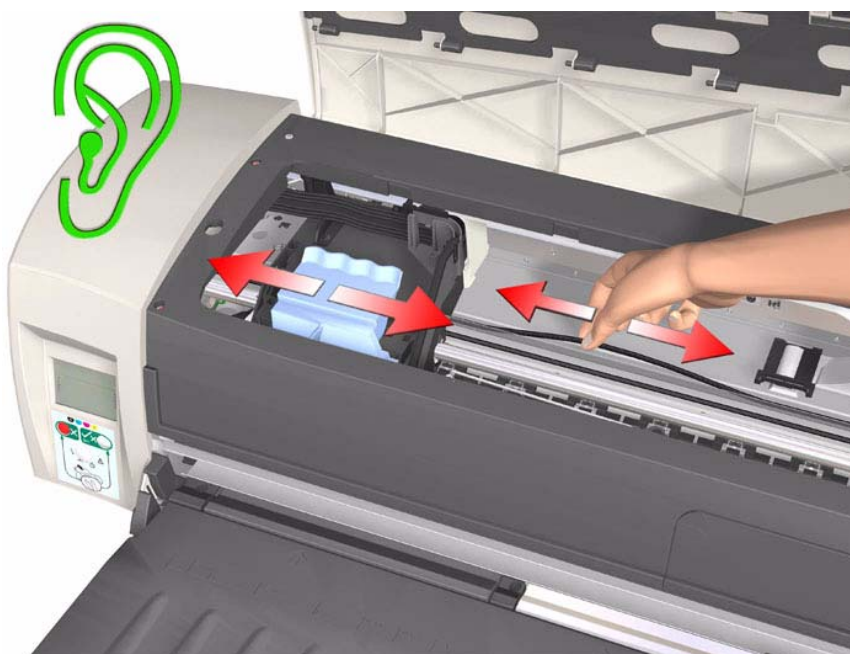
- 5** Using the belt, move the Carriage Assembly backwards and forwards over the Pivot Assembly (but staying on the left hand side of the printer), carefully listening for a scraping sound.

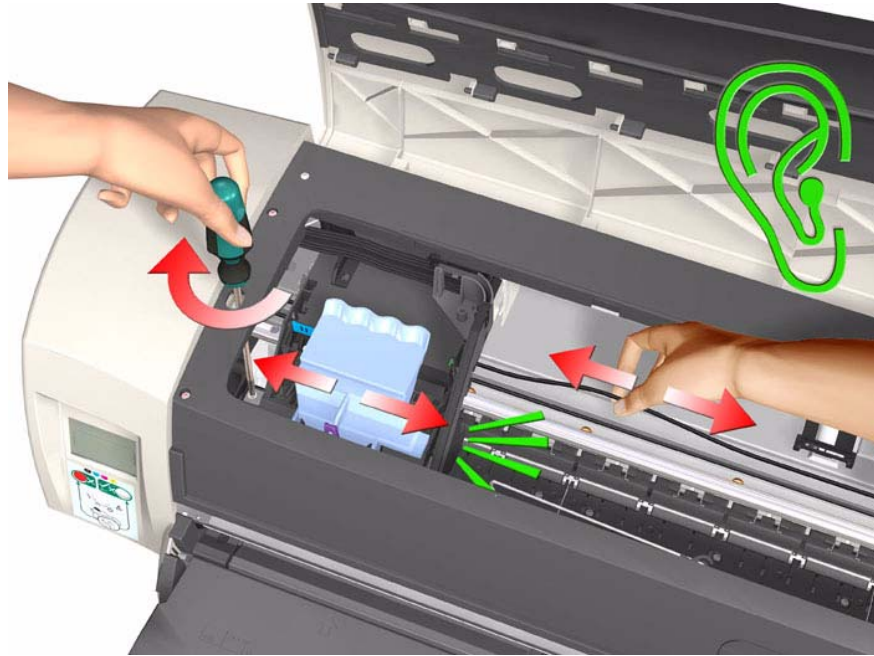
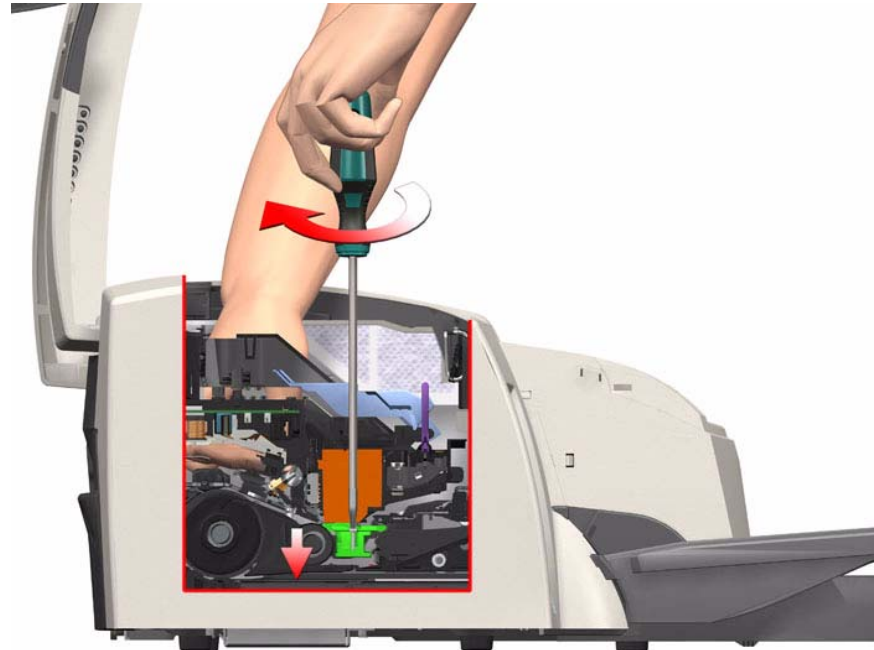
**Cross-Section - Lowering the Pivot Assembly**

- 6 If you hear a scraping sound, that means that the Pivot Assembly is too high and needs to be lowered slightly. Lower the Pivot Assembly slightly by turning the T-8 screw 1/8th of a turn clockwise and then check for a scraping sound again as shown previously in **step 5**.

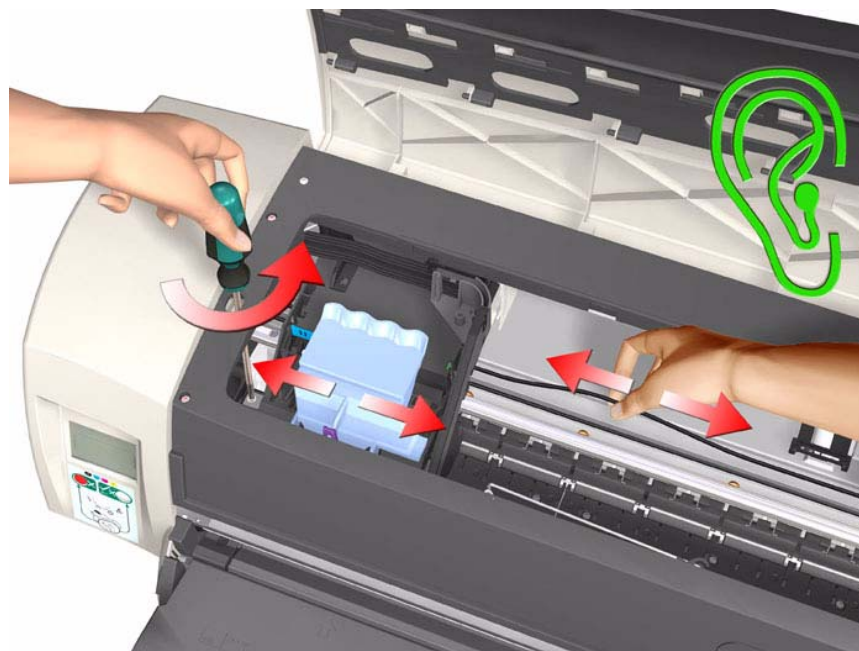
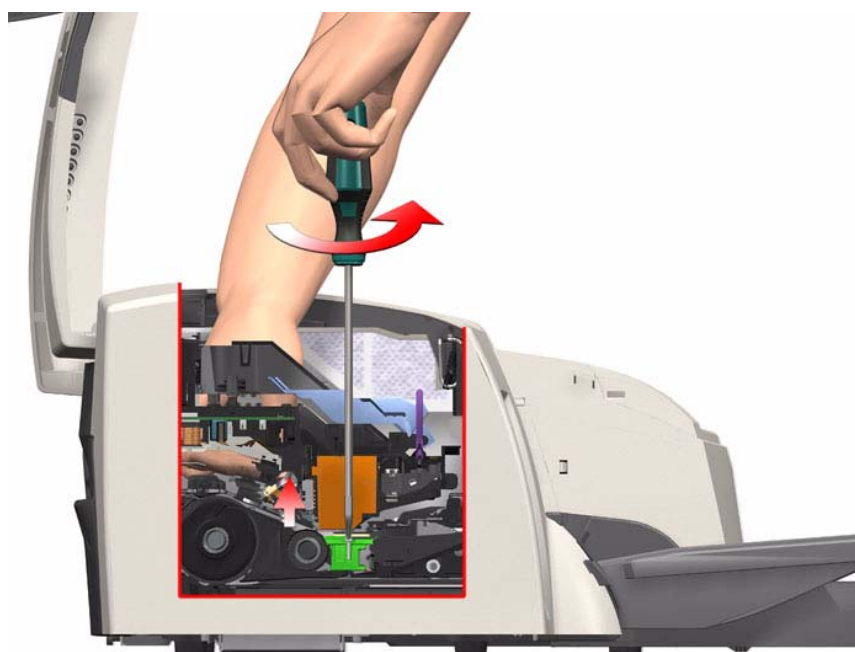
**Cross-Section - Raising the Pivot Assembly**

- 7** If you don't hear a scraping sound, that means that the Pivot Assembly is too low and needs to be raised slightly. Raise the Pivot Assembly slightly by turning the T-8 screw  $1/8$ th of a turn anti-clockwise and then check for a scraping sound again as shown previously in **step 5**.

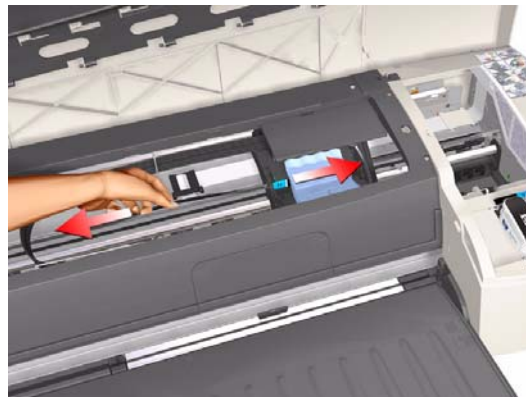
- 9** Move the Carriage Assembly to the right hand side of the Printer (to the position shown).

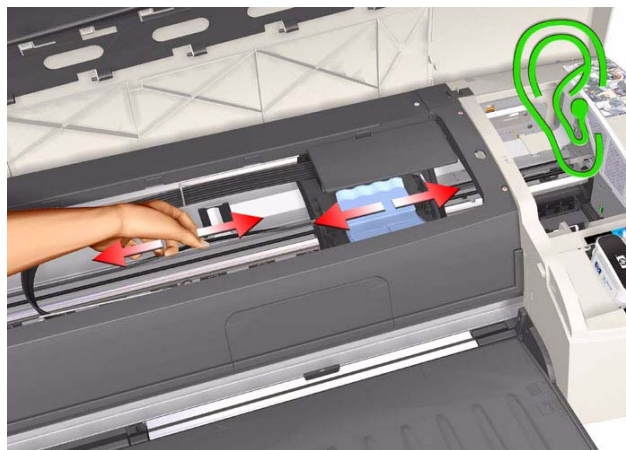
- 10** Using the belt, move the Carriage Assembly backwards and forwards over the Pivot Assembly (but staying on the right hand side of the printer), carefully listening for a scraping sound.

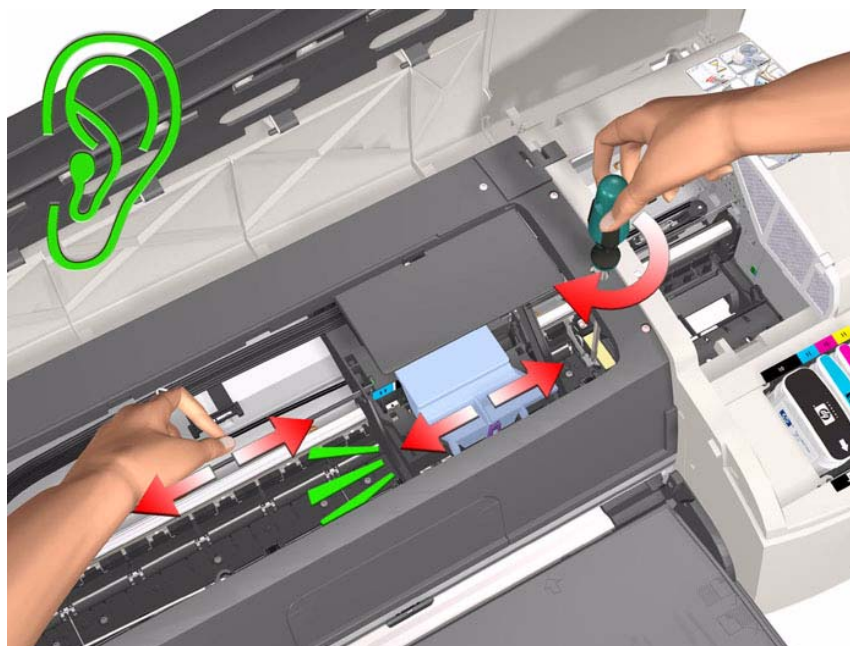
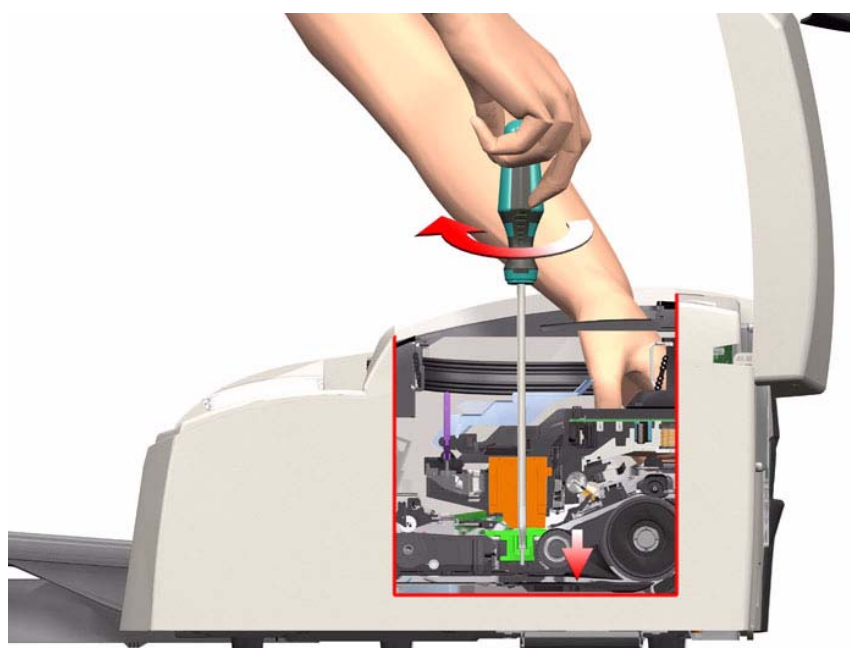
**Cross-Section - Lowering the Pivot Assembly**

- 11** If you hear a scraping sound, that means that the Pivot Assembly is too high and needs to be lowered slightly. Lower the Pivot Assembly slightly by turning the T-8 screw 1/8th of a turn clockwise and then check for a scraping sound again as shown previously in **step 10**.

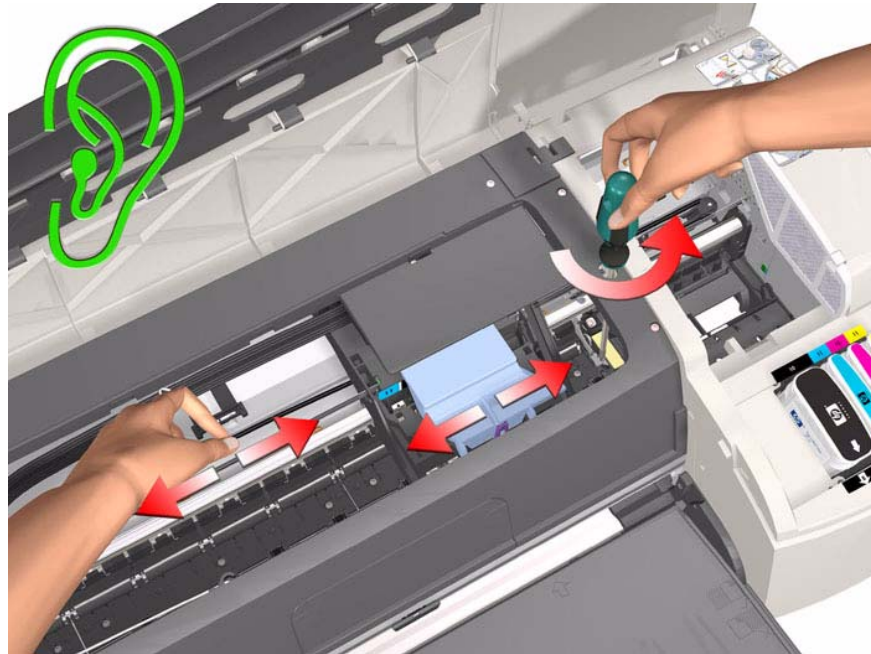
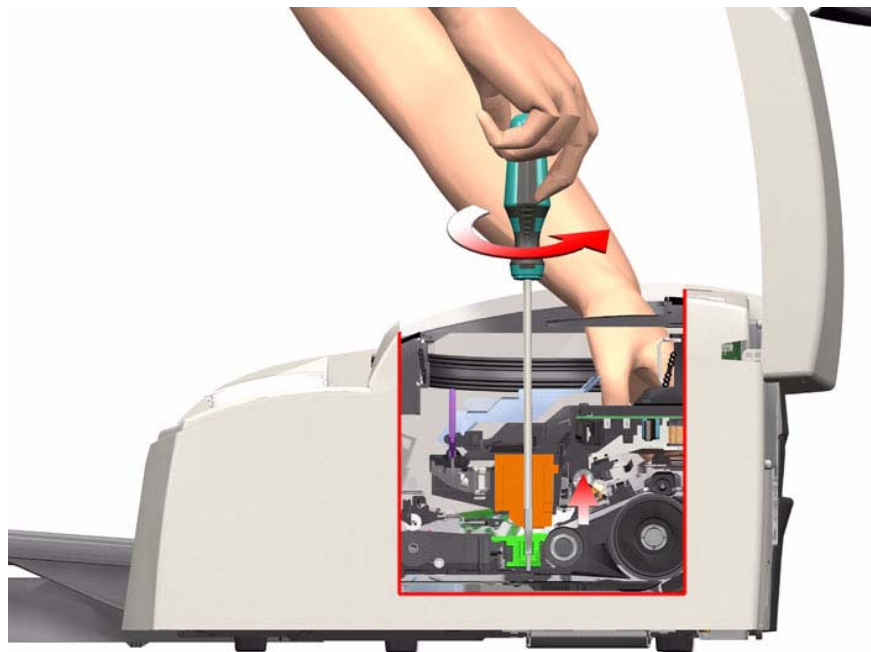
**Cross-Section - Raising the Pivot Assembly**

- 12** If you don't hear a scraping sound, that means that the Pivot Assembly is too low and needs to be raised slightly. Raise the Pivot Assembly slightly by turning the T-8 screw 1/8th of a turn anti-clockwise and then check for a scraping sound again as shown previously in **step 10**.

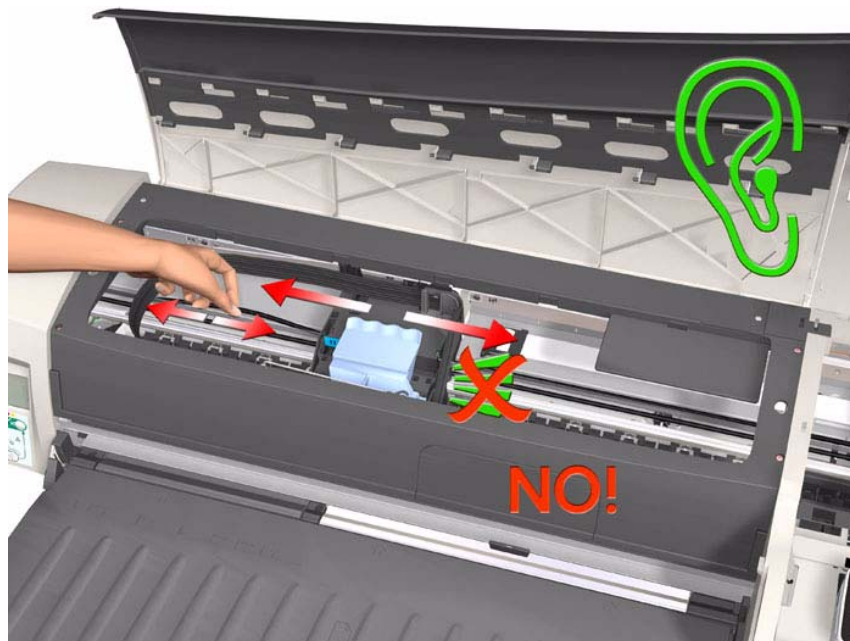
- 14** Move the Carriage Assembly along the length of the Printer, listening carefully for the scraping sound.
- 15** If you don't hear the scraping sound, then the PRS Adjustment is correct, go to **step 17**.

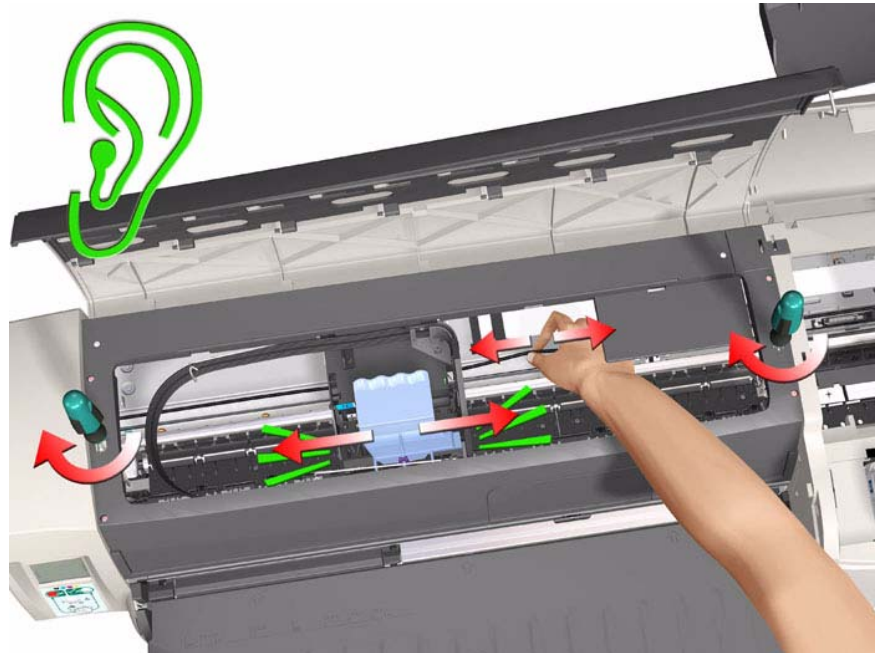
- 16** If you hear the scraping sound, then you will need to lower the Pivot Assembly slightly by turning the T-8 screw 1/8th of a turn clockwise on both the left and right hand side of the Pivot Assembly. Check for a scraping sound again as shown previously in **step 14**.
